# NuHart Superfund Site Update

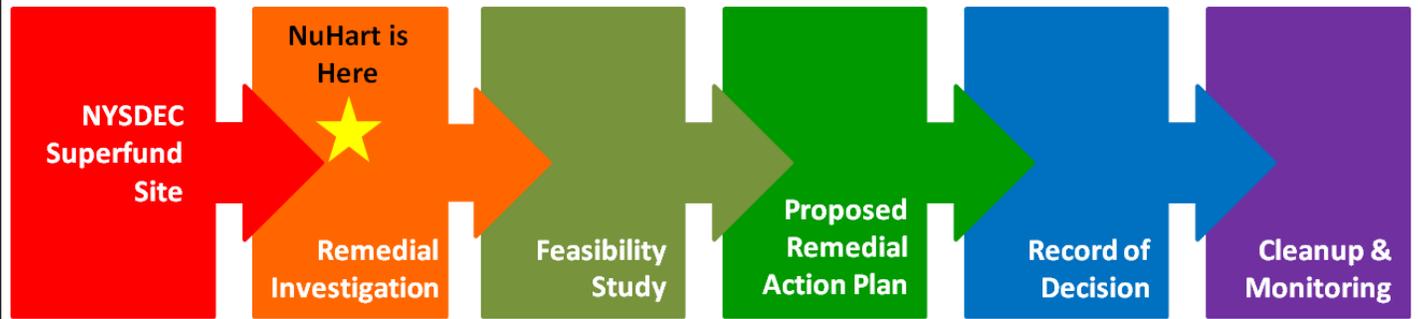
## Where is NuHart in the Superfund Process?

NuHart is a NY State Superfund Site and currently is at the **Remedial Investigation (RI)** stage of the process. The RI involves more environmental testing and includes human and ecological assessments to determine unacceptable exposure posed by the contaminants at the site. Once the RI is final, the next step is a **Feasibility Study (FS)** to identify the most effective cleanup technologies suitable for the site. An FS examines the environmental and economic implications of each alternative. An alternative is based on several criteria and the preferred alternative is described in detail in a **Remedial Action Plan**. The **Record of Decision (ROD)** follows as a legal document and finally, there is the cleanup and long-term monitoring of the site.

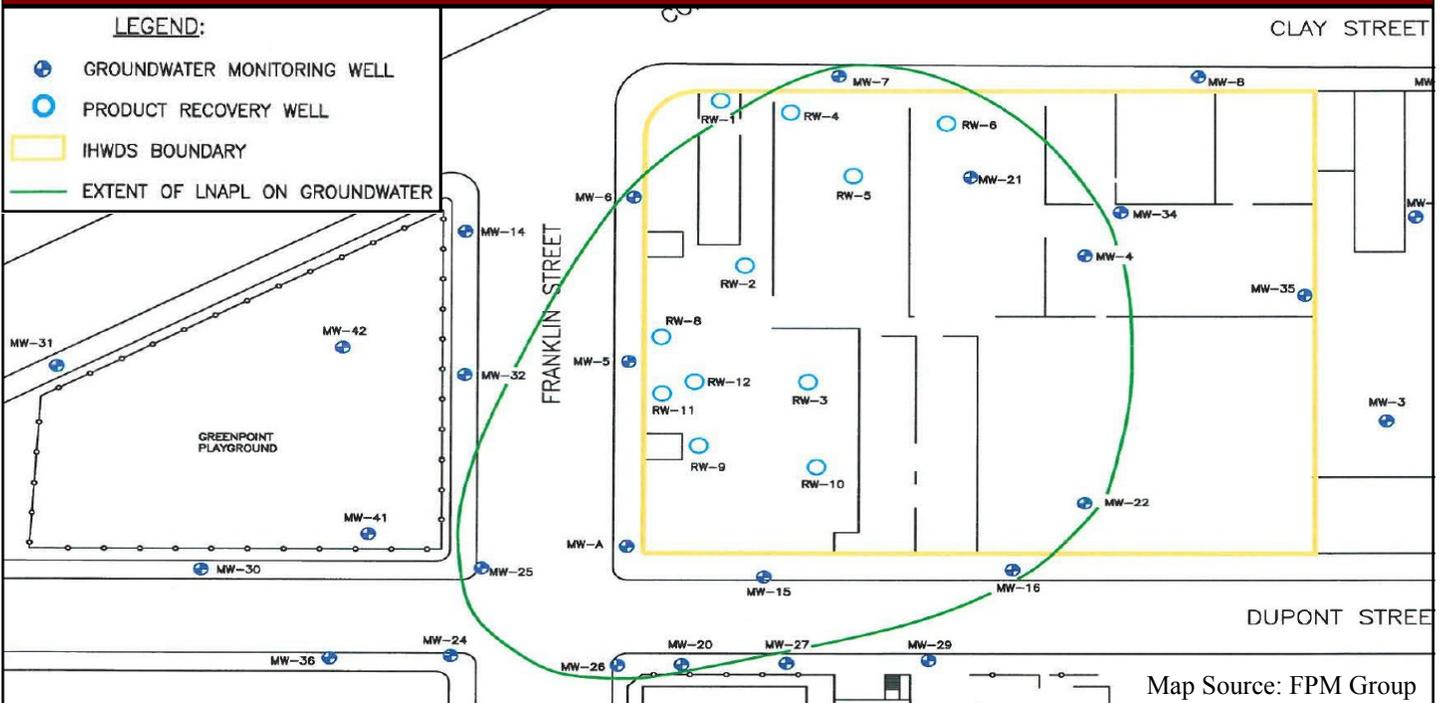
## Area of LNAPL Groundwater

**Offsite LNAPL:** New monitoring wells (MW) were installed west and southwest of the Site (see map below) last year. Phthalate, a plastic-softening chemical, was found in MW-37 at 15 ppb and in trace amounts in other wells. These sampling data are in the Remedial Investigation Report. Additional testing of the new wells in June did not show any LNAPL.

**LNAPL Removal:** No changes in the extent of the plume; 90 gallons of LNAPL was removed from the Recovery Wells (RW) in June and is stored on-Site and will be disposed of off-site.
